February 10, 2023

Project# 25669.143

RE: Route 632 Safety Study – Goochland County

SAFETY ASSESSMENT

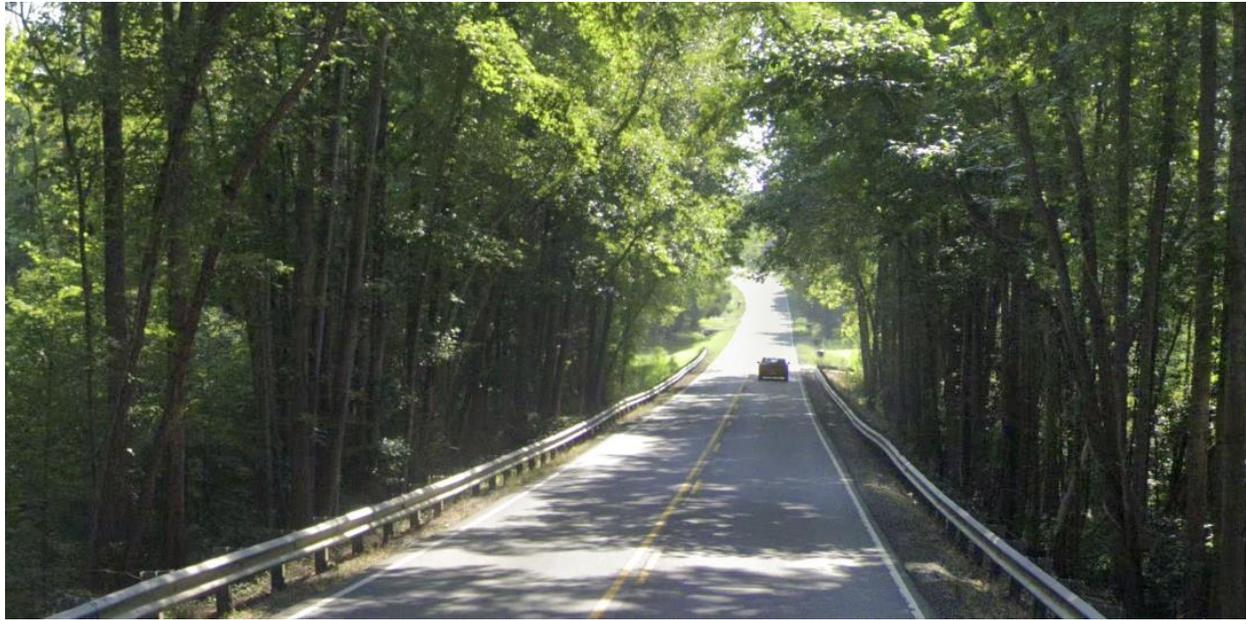
Figure 3. Typical undivided cross-section with guardrails on Route 632

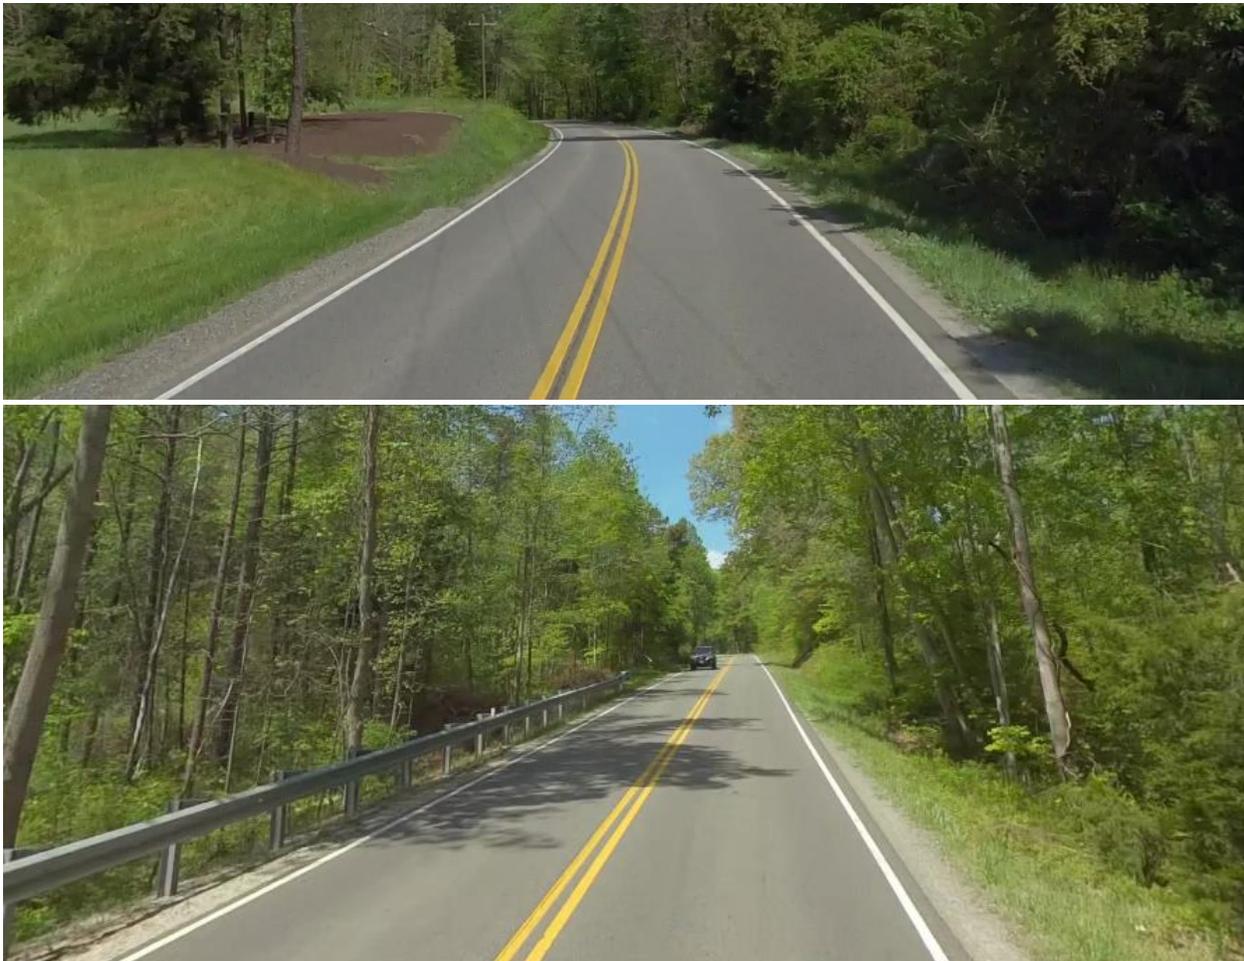
Most of the corridor currently has either no paved shoulders or paved shoulders that are less than two feet in width. **Figure 4** illustrates a few examples of sections with narrowly paved shoulders. **Figure 5** provides an inventory of shoulder width along the study corridor, including sections where guardrail is present.

Figure 4. Narrow paved shoulders along Route 632

As such, it is recommended that two-foot shoulders be provided where feasible along the corridor. A study evaluating lane departure countermeasures indicated providing paved shoulders two feet in width on both sides of a two-lane undivided roadway is anticipated to reduce roadside crashes by 34 percent (a crash modification factor of 0.66).⁶

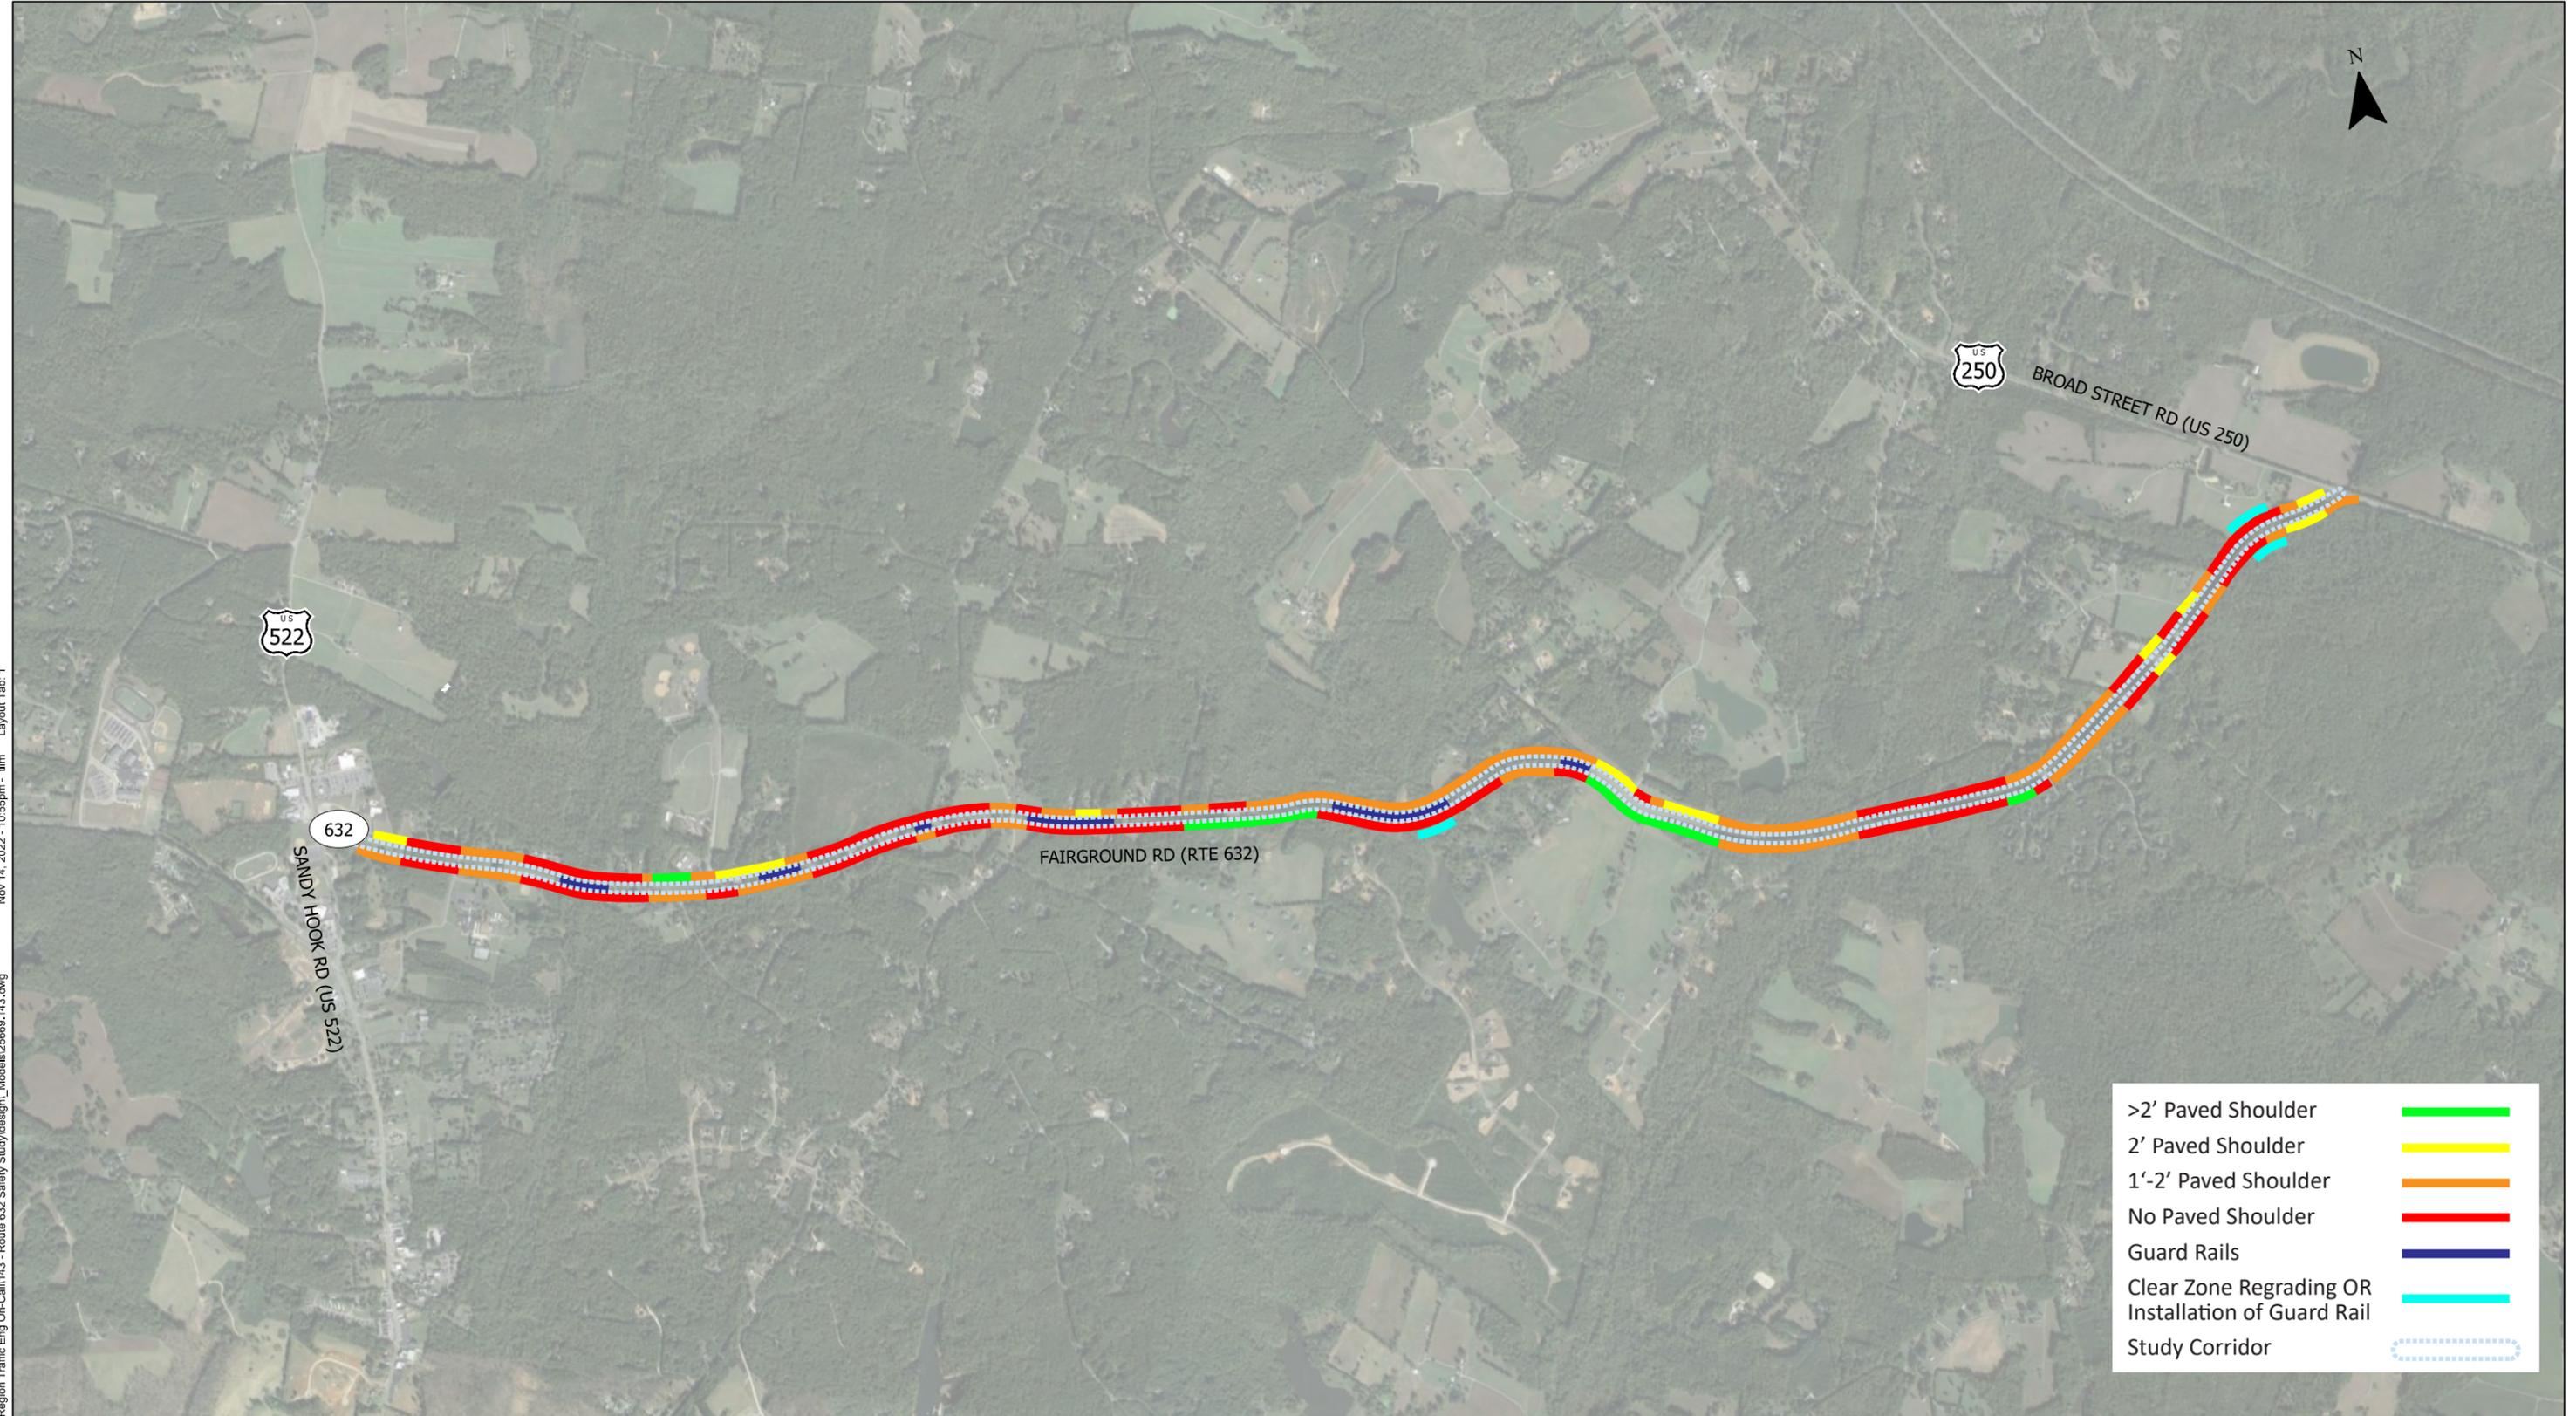
Figure
5

Roadway Edge Conditions
Goochland County, VA

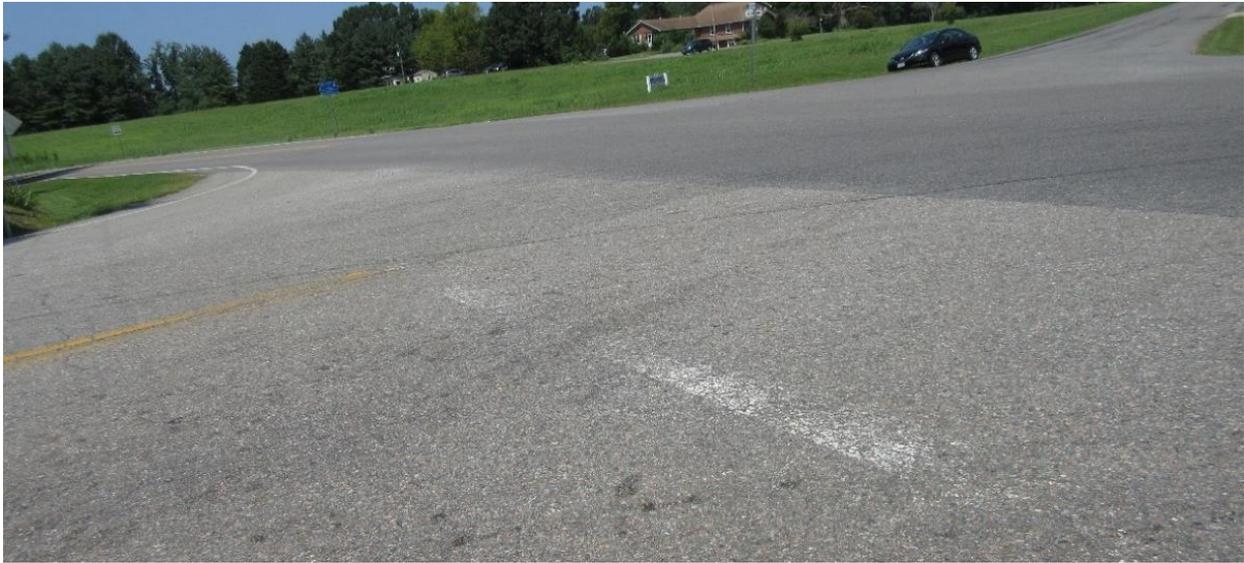
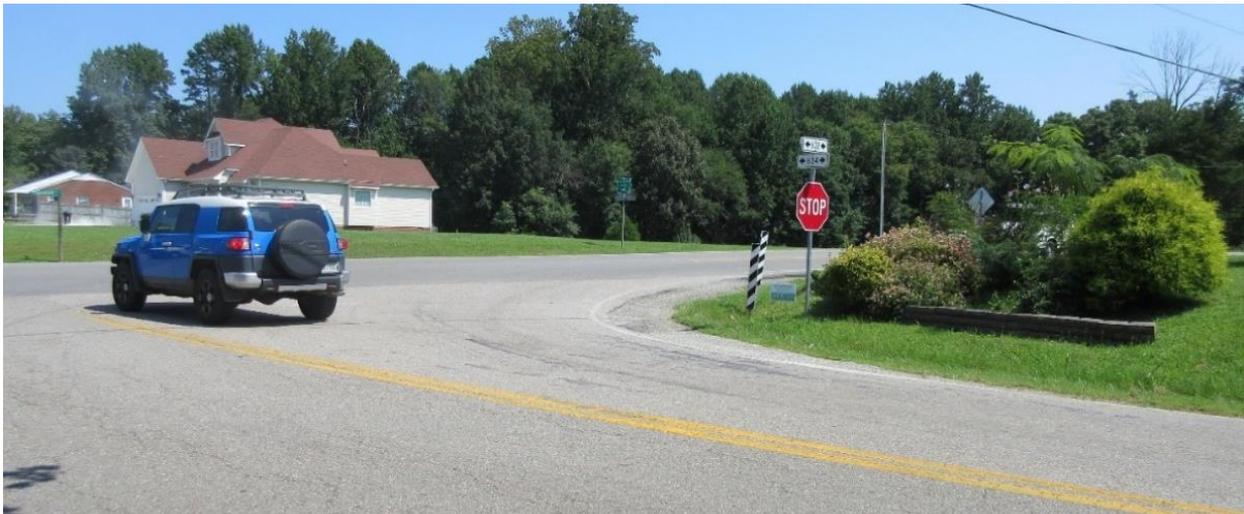
The field visit also illustrated several minor street approaches at several unsignalized intersections have either faded or no stop bars. The presence of stop bars at unsignalized intersections help to direct the attention of drivers to the presence of the intersection, as well as help delineate a safe location for minor road vehicles to stop. This, in turn, can help reduce the potential for angle crashes¹. The following locations and approaches were identified as having stop signs without stop bars:

- Route 632/634 (Maidens Road, NB approach)
- Route 632/665 (Hidden Rock Lane)

Figure 6. Faded and missing pavement stop bars at Route 632/634 (Maidens Road)

Through the field visit, the study team observed stop-controlled approaches along Route 632 without a stop bar present and/or a faded stop bar present. The study team recommends restriping of the faded stop bars and installation of stop bars at stop-controlled approaches that currently do not have a stop bar. Installing a stop bar will provide guidance on where oncoming vehicles should be while waiting for a gap in traffic to safely enter Route 632. In certain instances, the stop bars were found to be located too close or too far from Route 632, so they are recommended to be relocated.

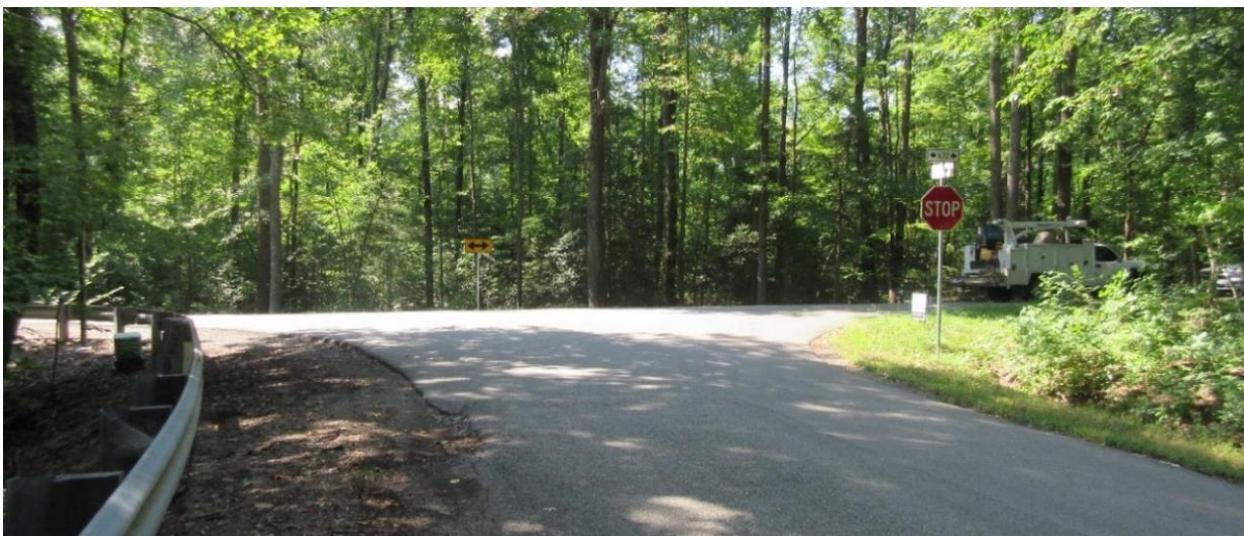
In addition, some stop bars and stop signs at intersections were observed to be located too far upstream from the intersection to provide adequate sight lines. At the northbound approach of the Route 632/Route 634 (Maidens Road) intersection, the stop bar was located too close to the intersection and westbound left-turning vehicles were observed to regularly cross the stop bar. This behavior could result in angle crashes between turning and stopped vehicles. **Figure 6** illustrates the current conditions at the Route 632/Route 634 intersection. At the southbound approach of Route 632/Route 637 (Hawk Town Road) intersection, the stop sign is located farther from the intersection and vehicles may experience poor sight distance due to adjacent trees. **Figure 7** illustrates the pavement marking conditions at the Route 632/Route 637 intersection.

Figure 7. Stop sign and no stop bar at Route 632/637 (Hawk Town Road)

The study team recommends that horizontal alignment intersection warning signs (W1-10) be installed on approach to Route 632/637 (Hawk Town Road). Sight distance challenges are currently introduced by the horizontal curve in the roadway geometry. Installing a W1-10 sign can alert drivers of the upcoming intersection and possible turning vehicles up ahead (many rear end crashes happen at the eastbound approach). **Figure 25** displays an example of a W1-10 sign.

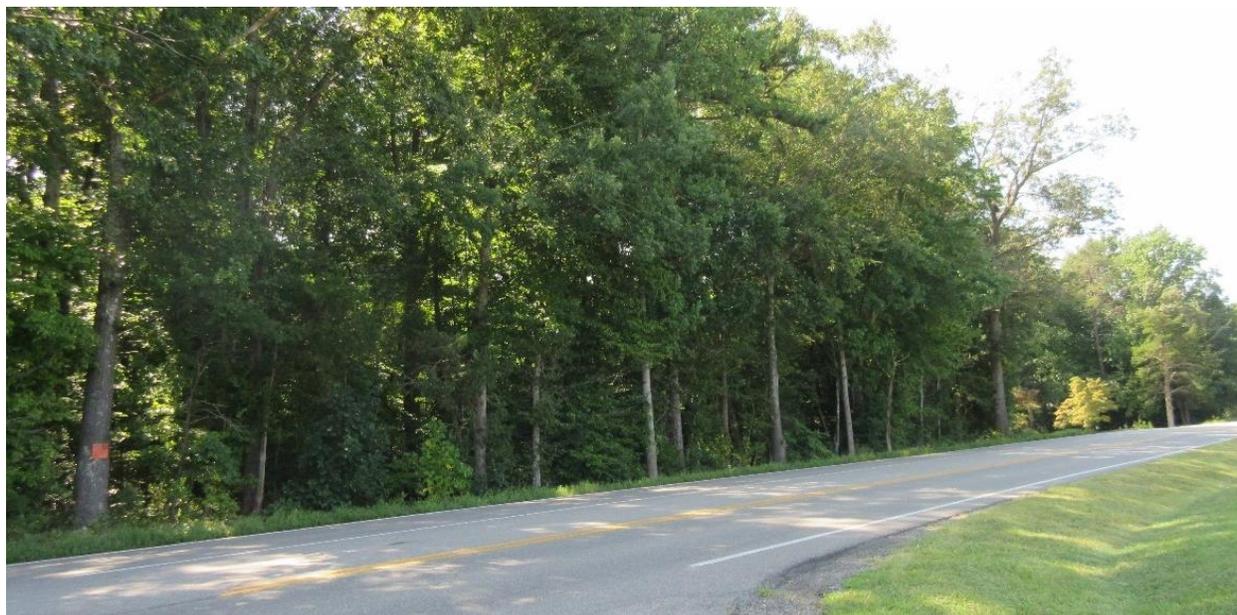
Several turn lanes along Route 632 were observed without left-turn or right-turn arrow pavement markings. While not required by the *Manual on Uniform Traffic Control Devices (MUTCD)* in every instance based on engineering judgement², a lack of lane-use arrow markings for turn lanes may to driver confusion and incorrect lane usage. Turn lane arrow pavement markings were observed missing along Route 632 at the following intersections:

Figure 8. Eastbound turn lane missing arrow pavement markings on Route 632 at The Preserve Drive

Through the field visit, the study team noted many turn lanes on Route 632 lack turn lane arrow pavement markings. The study team recommends installing turn lane arrow pavement markings at identified locations to improve driver awareness and guidance and discourage improper movements.

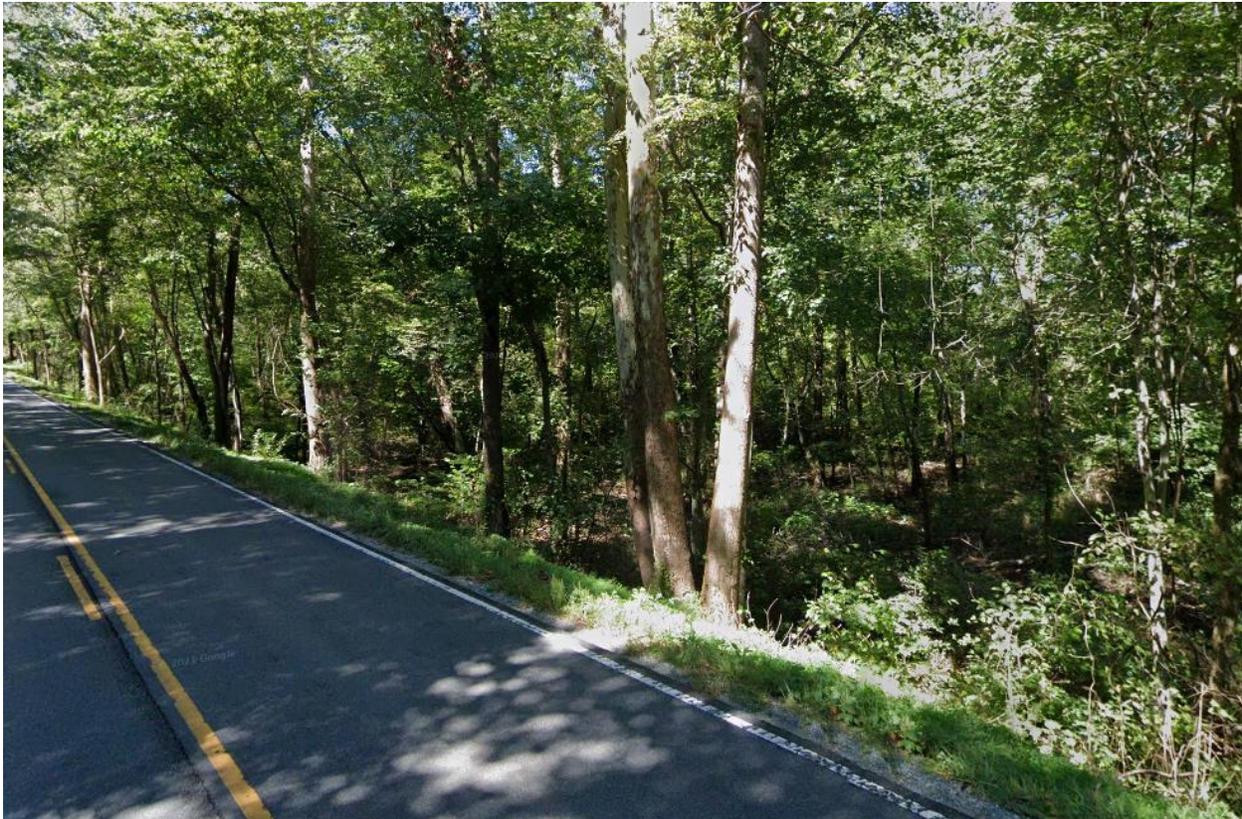
Steep roadside slopes are present in some sections of the corridor and appear to be non-recoverable for vehicles that might exit the roadway. At the edge of many of these slopes is a dense tree line, which can lead to higher severity fixed-object crashes. Where re-grading of the roadside slopes is not feasible, segments may benefit from tree trimming to increase clear zones or the addition of guardrail. These locations include segments within the sections:

Figure 9. Example of Non-Recoverable Slopes (Route 632 near Beaverdam Creek)

The study team observed several locations along the corridor where the roadside slopes in the recoverable zones in the clear zone appeared steep. If these slopes do not meet the recommended grades, drivers may have difficulty regaining control of their vehicle if they exit the roadway. Given that 32 percent of all crashes in the analysis period were run-off-the-road crashes, the study team recommends the identified locations with non-recoverable slopes be flattened to 10:1 to increase the probability of recovery where feasible.

In locations where re-grading to meet this slope is not feasible, the study team recommends that the either clear zone be increased to reduce the risk of run-off-the-road crashes (preferred) or guardrail be introduced to help prevent vehicles from exiting the roadway. Where feasible, increasing the clear zone is preferable to the installation of guardrail, as guardrail increases the potential for property damage, has the potential to deflect vehicles back into the opposing travel lane, and comes with increased maintenance costs. In segments where work to develop recoverable slopes extended outside of the existing right-of-way or where the cost of construction was expected to exceed guardrail installation, increases to the clear zone or installation of guardrail are called out.
