February 10, 2023

Project# 25669.143

RE: Route 632 Safety Study – Goochland County

SAFETY ASSESSMENT

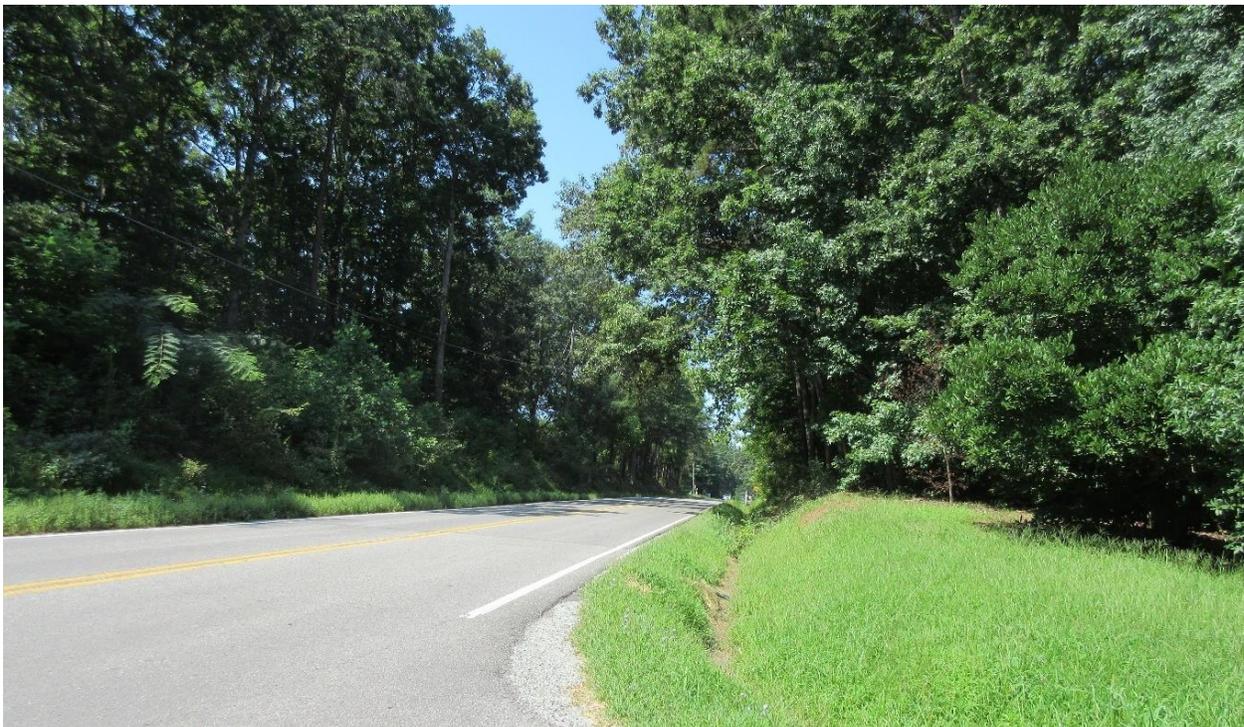
Figure 2. Typical undivided cross-section on Route 632

Figure 2 illustrates a typical view of the section along the corridor. **Figure 3** displays a typical view of a section along the corridor with guardrails.

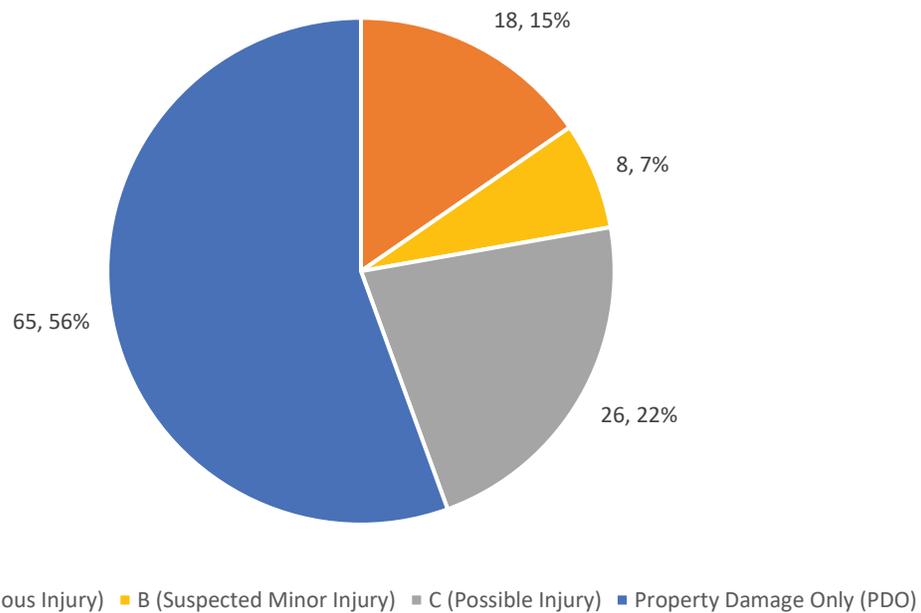
Figure 10. Crash Severity, January 2017 to December 2021

Figure 10 summarizes the reported crash types by severity.

- 65 of the 117 crashes recorded resulted in property damage only. This accounted for 56 percent of the total crashes.
- No crashes resulted in a fatality, and eighteen crashes (15 percent of total crashes) resulted in a suspect serious injury.

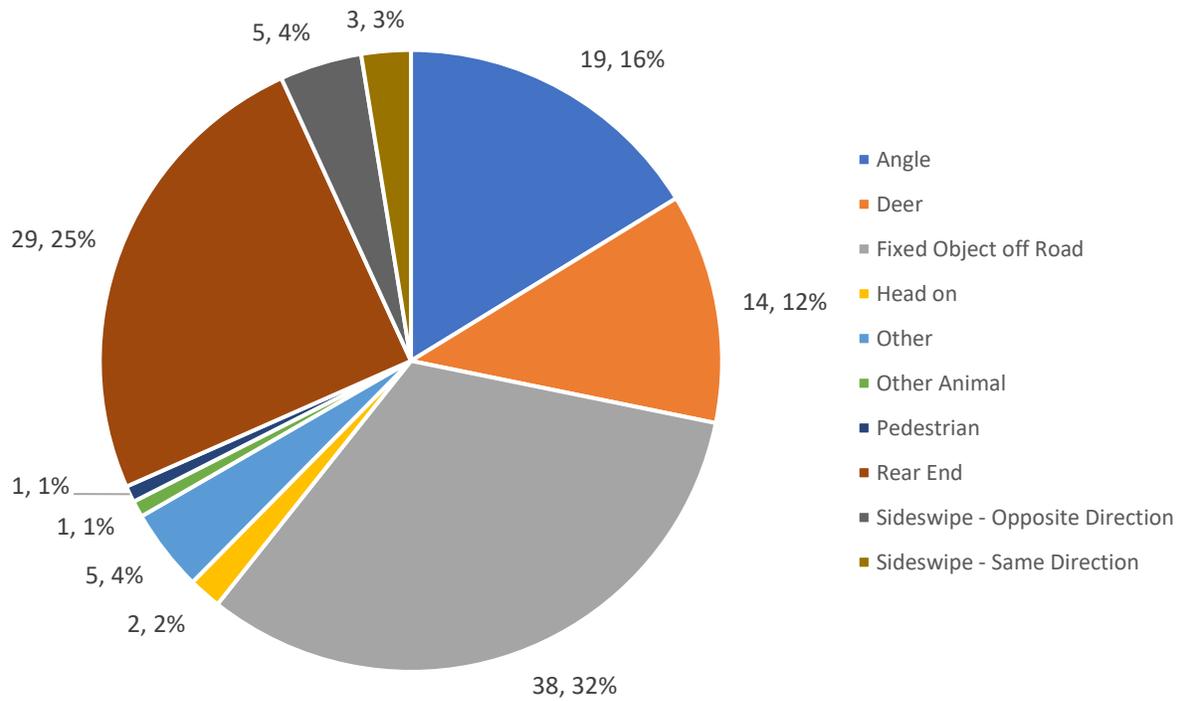
Figure 11. Vehicle Crash Types, January 2017 to December 2021

Figure 11 identifies the crash types of the reported crashes.

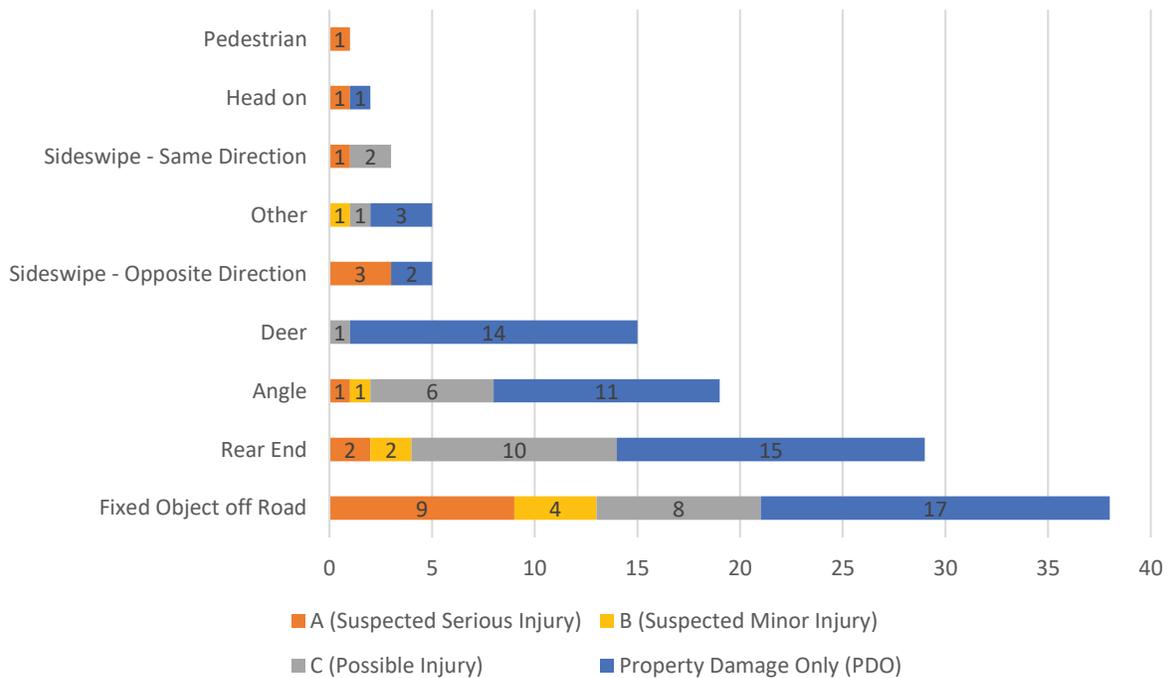
Figure 12. Reported Crash by Crash Type and Severity, January 2017 to December 2021

Figure 12 summarizes reported crashes by crash type and severity.

- Of the 38 fixed object off road crashes, 44 percent resulted in property-damage only, 24 percent resulted in suspected serious injury, and the other 32 percent resulted in possible or suspected minor injury.
- Over 93 percent of crashes with deer and other animals were property-damage only.

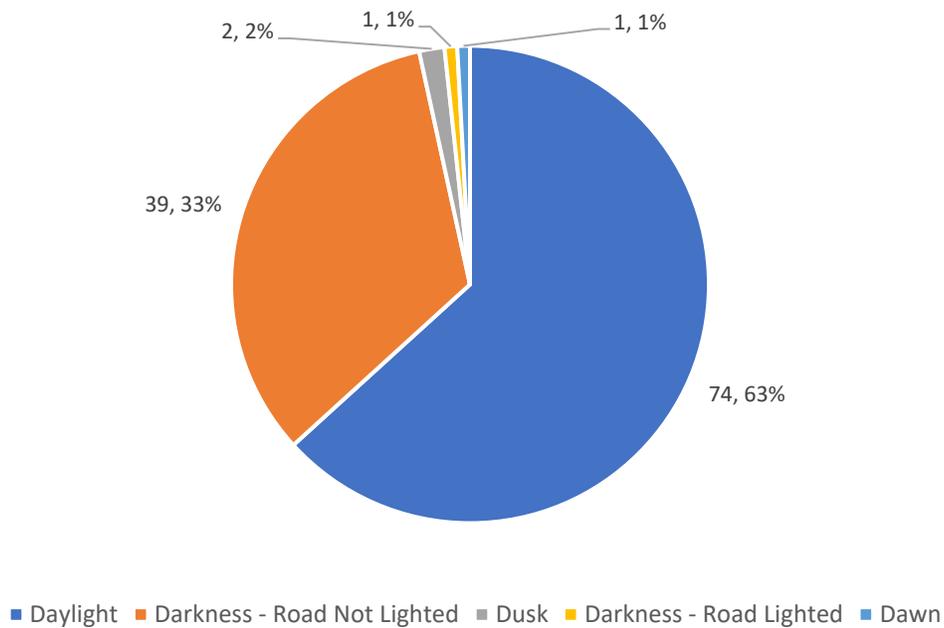
Figure 13. Reported Crashes by Lighting, January 2017 to December 2021

Figure 13 displays the study corridor crash count by reported lighting condition.

- More than half of the crashes (63 percent) occurred under daylight conditions.
- 33 percent of the crashes occurred in dark conditions. There is limited lighting along the corridor with wooded areas and occasional residences.

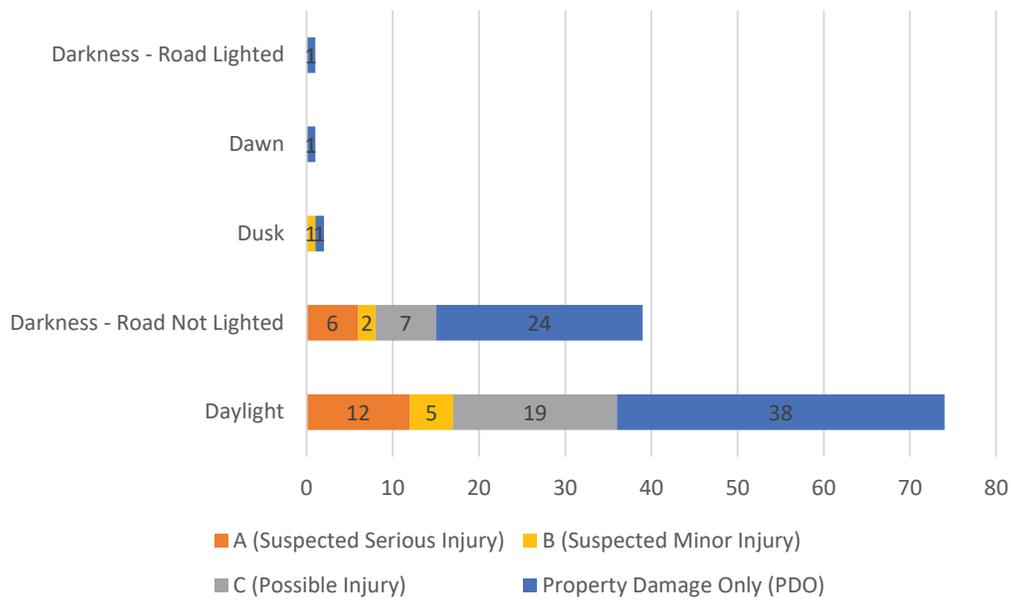
Figure 14. Reported Crashes by Lighting and Severity, January 2017 to December 2021

Figure 14 summarizes the reported crashes by lighting and severity.

- 15 percent of crashes that occurred during unlit, dark roadways resulted in a suspected serious injury.
- 16 percent of crashes that occurred during daylight conditions resulted in a suspected serious injury.

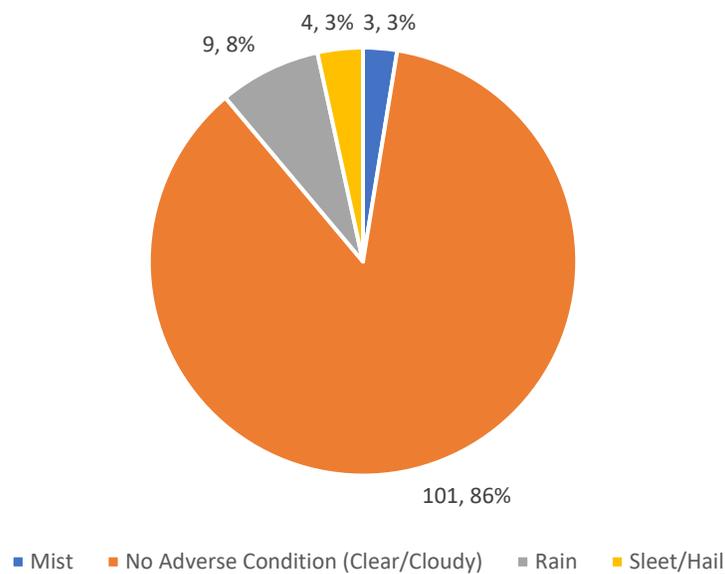
Figure 15. Reported Crashes by Weather Condition, January 2017 to December 2021

Figure 15 provides the study corridor crash count by weather condition.

- The majority of crashes (86 percent) occurred under dry conditions.
- Rain, sleet/hail, and mist conditions accounted for 16 of the total crashes (14 percent)

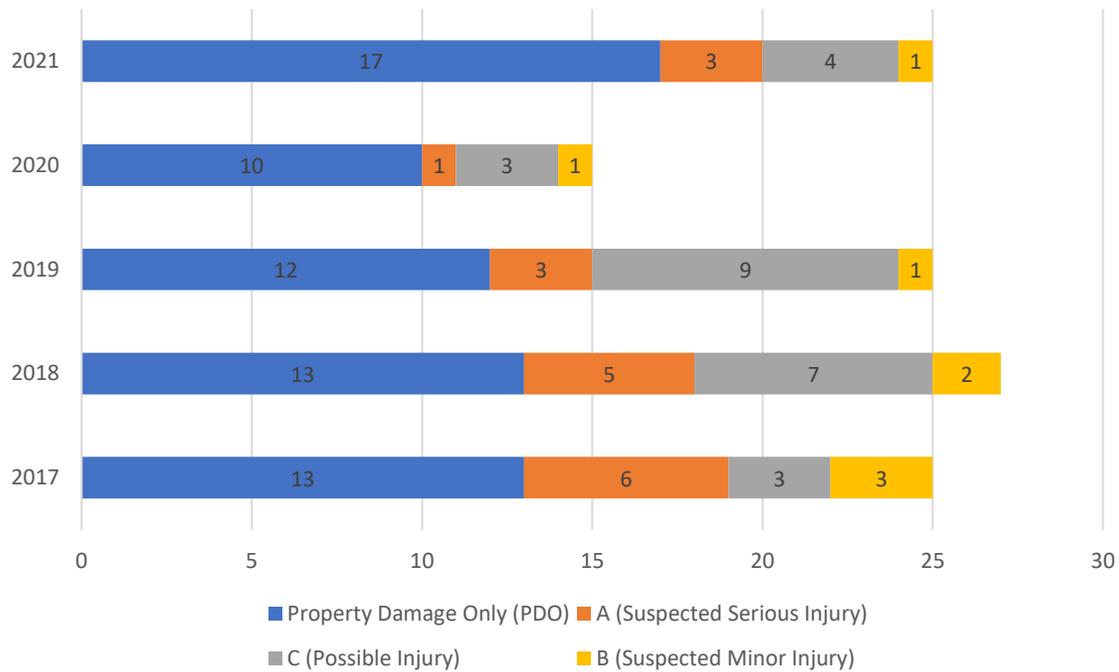
Figure 16. Reported Crashes by Year and Severity, January 2017 to December 2021

Figure 16 summarizes the study corridor crash count by year and severity.

- 2018 had the highest count of crashes (27 total crashes). 2017, 2019, and 2021 each had 25 total crashes.
- The frequency of crashes per year was between 15 to 27 crashes.

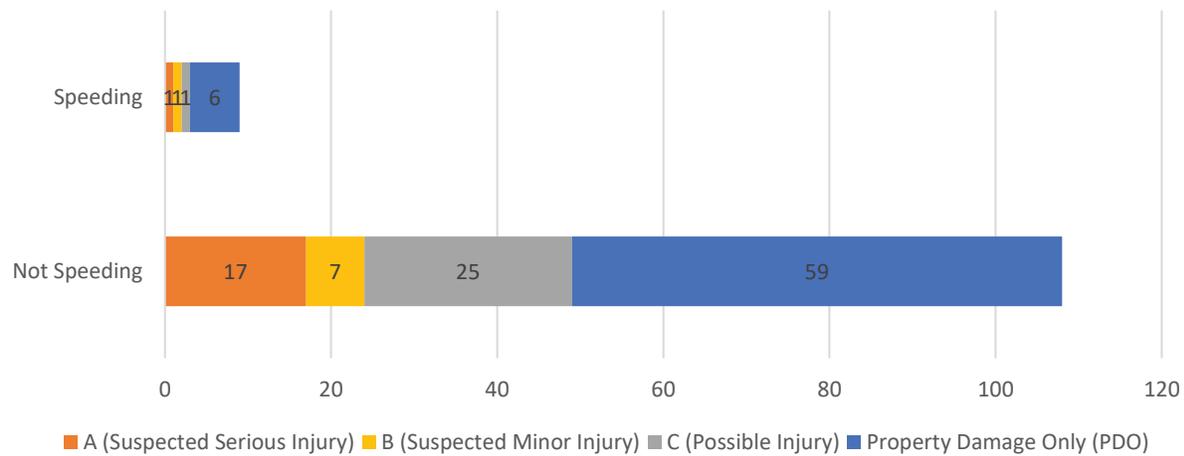
Figure 17. Reported Crashes by Speeding and Severity, January 2017 to December 2021

Figure 17 summarizes the study corridor crash count by speeding and severity. Statistics related to speeding are based on FR-300 reports, which are based on speculation and should be taken as a reference only.

- Less than eight percent of total crashes involved speeding.
- One of the nine total crashes (11 percent) involving speeding resulted in a suspected serious injury.

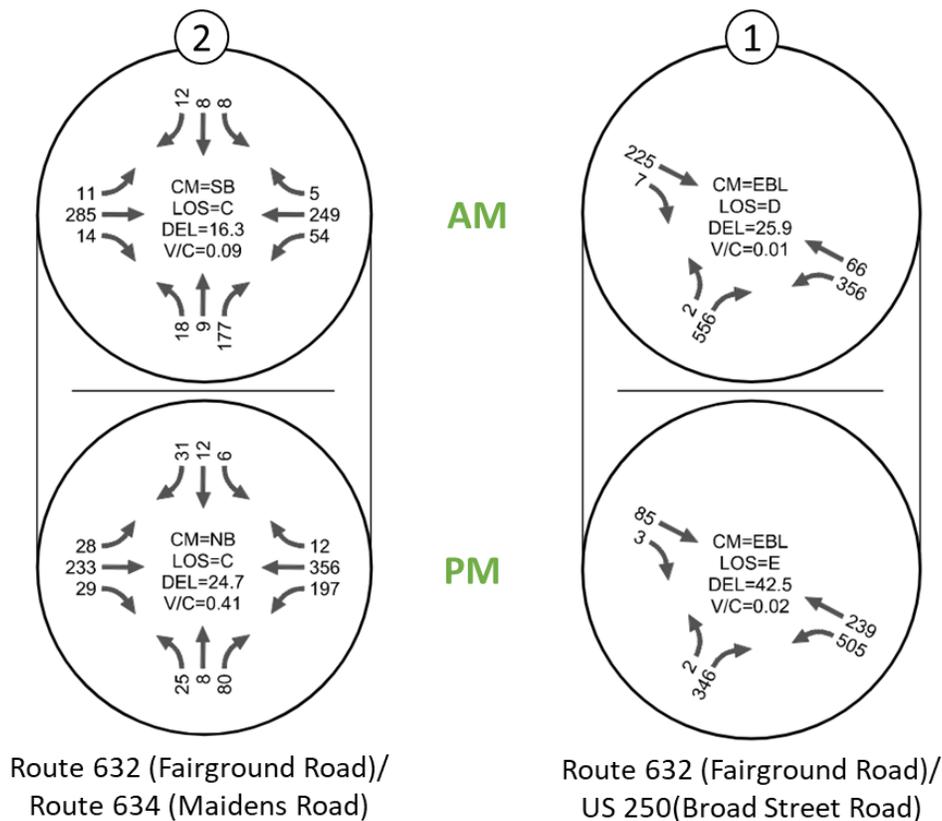
Figure 19. Year 2022 (Existing) Traffic Operations at Priority Intersections

Figure 19 summarizes the existing weekday a.m. and weekday p.m. peak hour operations at the priority intersections. **Table 2** displays the Synchro 11 peak hour levels of service, delay, and 95th-percentile queue for each lane group by intersection. **Attachment E** contains the existing conditions level of service worksheets.

As shown, the critical eastbound left-turn movement at the US 250/Route 632 intersection operates at LOS D and LOS E during the weekday a.m. and weekday p.m. peak hours, respectively. This movement only serves two vehicles during each of the weekday peak hours. At the Route 632/Route 634 intersection, the critical movement operates at LOS C during both peak hours.

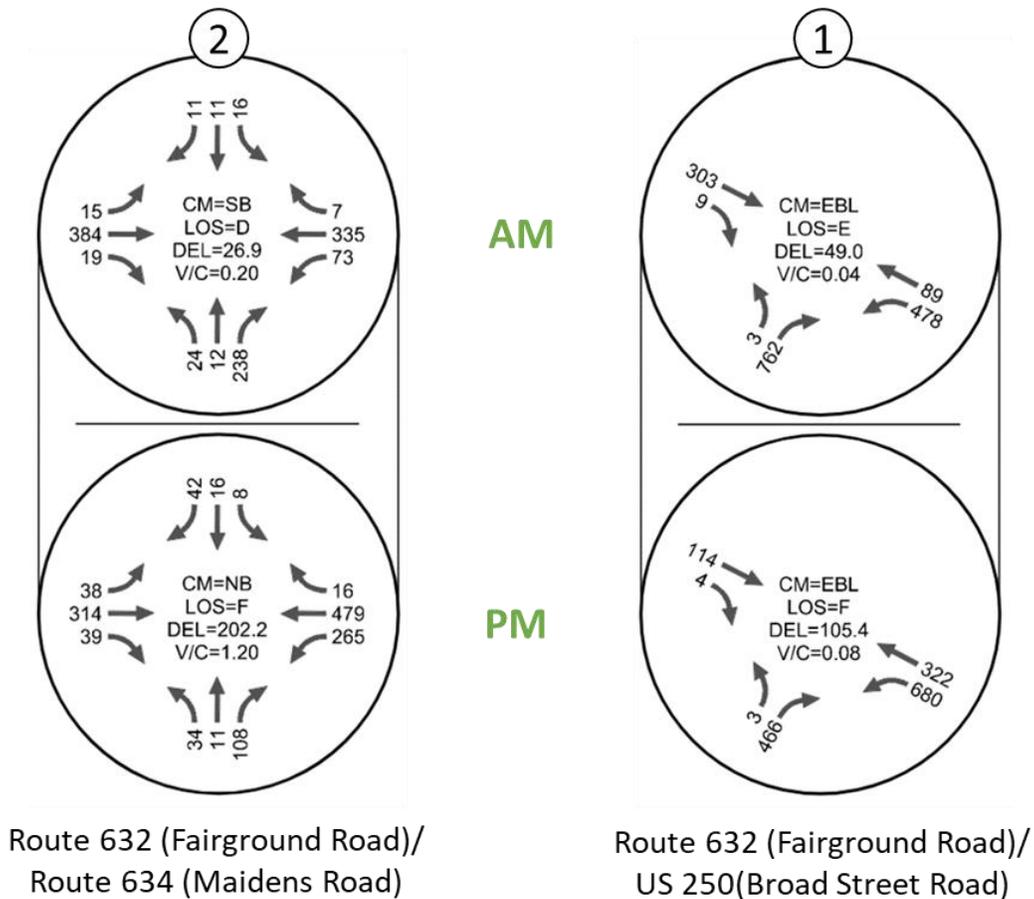
Figure 20. Design Year 2042 Traffic Operations at Priority Intersections

Figure 20 summarizes the design year 2042 no-build weekday a.m. and weekday p.m. peak hour operations at the study intersections. **Table 4** displays the Synchro 11 peak hour levels of service, delay, and 95th-percentile queue for each lane group by intersection. The critical eastbound left-turn movement at the US 250/Route 634 intersection is forecast to operate at LOS F and LOS D during the weekday a.m. and weekday p.m. peak hours, respectively. While the delays are projected to be high, the critical movement is only projected to serve three vehicles during each of the weekday peak hours and operate well below capacity. Each of the other movements are anticipated to operate with more reasonable levels of delay.

The delays on the minor street approaches to the Route 632/Route 634 intersection are anticipated to grow substantially with the critical northbound movement anticipated to operate at LOS F during the weekday p.m. peak hour. Queues on the northbound approach are forecast to reach 10 vehicles long. This increase in delay will likely lead to drivers on the minor approaches accepting smaller gaps in traffic on the mainline (Route 632) to complete their maneuver. This, in turn, may lead to an increase in angle crashes.

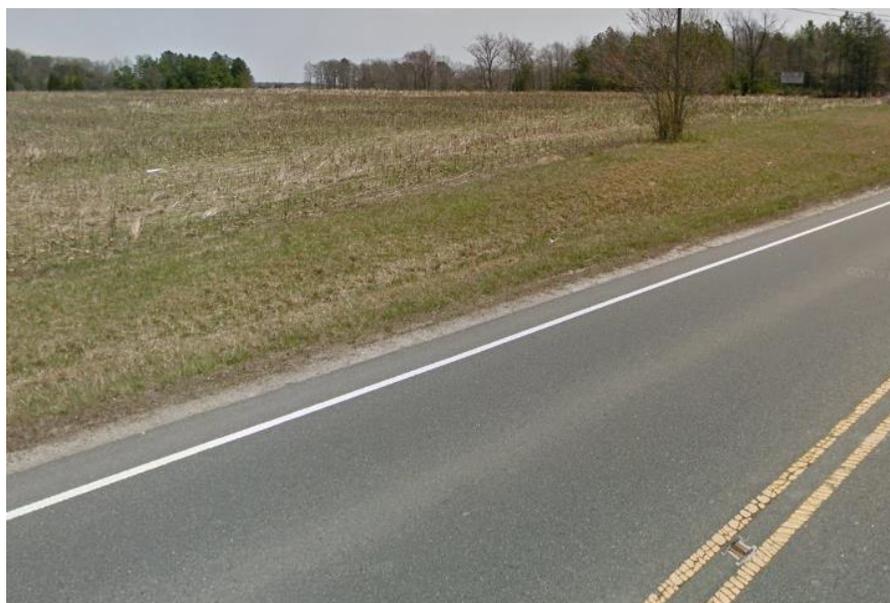
Figure 21. Example of 2-ft Shoulders (Source: Google Streetview)

As described in the field visit section, many segments along the corridor have narrow paved shoulders with less than two feet of width. The lack of sufficient paved shoulders on both sides of the corridor leaves little recovery room for vehicles errantly deviating from the travel way, which can lead to an increase in run-off-the-road and fixed object crashes. It can also lead to an increase in head-on and sideswipe crashes between vehicles in the opposing direction⁴, as any deviation over the roadway centerline becomes more difficult to avoid for an opposing vehicle. However, providing shoulders that are too wide can lead to an increased prevalence of speeding along the corridor. The extra room for recovery on the outside edge of the roadway creates a sense of comfort for drivers who now have more room for error. The Highway Capacity Manual, 6th Edition estimates for every one-foot of additional shoulder width results in a 1.3 to 1.7 mile-per-hour increase in speed on a two-lane roadway⁵. Therefore, widening shoulders need to strike a balance of providing room for recovery and avoidance, while not allowing for drastic increases in speed. Providing two feet of paved shoulder width on both sides of the corridor where possible would help provide extra width for recovery. **Figure 21** displays an example of a two feet wide paved shoulder.

As such, it is recommended that two-foot shoulders be provided where feasible along the corridor. A study evaluating lane departure countermeasures indicated providing paved shoulders two feet in width on both sides of a two-lane undivided roadway is anticipated to reduce roadside crashes by 34 percent (a crash modification factor of 0.66).⁶

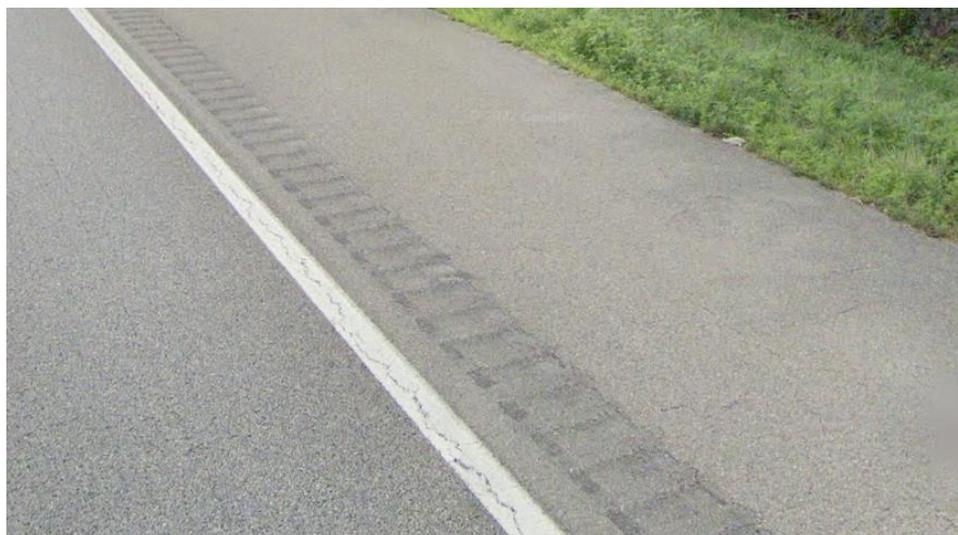
Figure 22. Example of Shoulder Rumble Strips (Source: Google Streetview)

The study team recommends that sinusoidal shoulder rumble strips be installed along the corridor to alert drivers who may be exiting the travel lane and reduce the risk of run-off-the-road crashes. Based on the crash analysis, run-off-the-road crashes made up the highest proportion of total crashes observed on the corridor. Additionally, most of the corridor has narrow paved shoulders of less than two-foot widths due to constraints introduced by local topography. Rumble strips are indentations in the pavement that when driven over, create noticeable sound and vibrations to warn drivers that they have left their lane. VDOT standards call for the use of sinusoidal rumble strips, which have been shown to produce less exterior noise compared to traditional rumble strips due to the wave-like pattern. Shoulder rumble strips should be installed per guidance in the corresponding instructional and informational memorandum (IIM-LD-212.7).⁷ **Figure 22** displays an example of shoulder rumble strips.

Based on NCHRP Report 641, installing edge line rumble strips has a crash modification factor of 0.67 for run-off-the-road crashes, indicating a reduction in crashes and an effective safety improvement.⁸ Implementing shoulder rumble strips will improve safety conditions along the corridor without extensive widening of the paved shoulder.

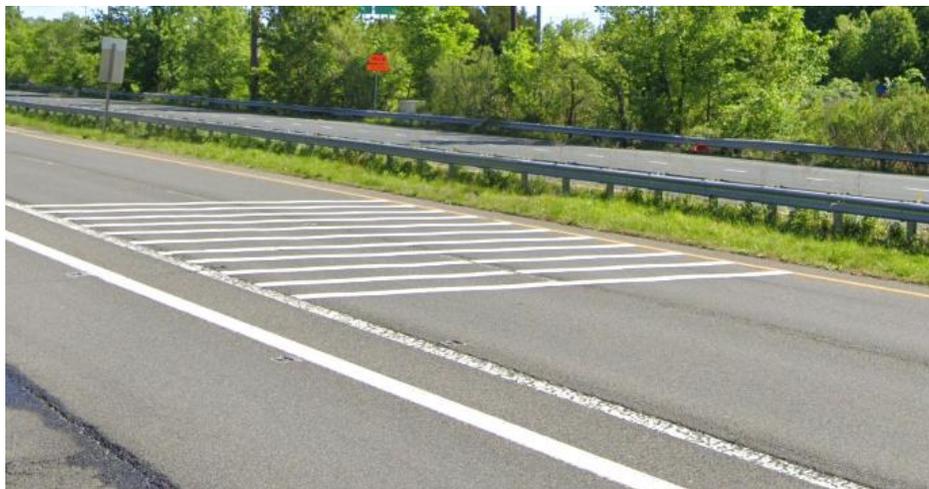
Figure 23. Example of Transverse Rumble Strips (Source: Google Streetview)

The study team recommends that transverse rumble strips be installed at increments along the corridor. **Figure 23** displays an example of installed transverse rumble strips. As previously discussed, the 85th percentile speeds were higher than the posted speed limit in both directions at the two data collection points. Transverse rumble strips can act as a traffic calming device to alert drivers to slow down and take more caution while driving along the corridor. By encouraging less speeding, the risk of exiting the roadway and/or occurrence of run-off-the-road crashes may be reduced.

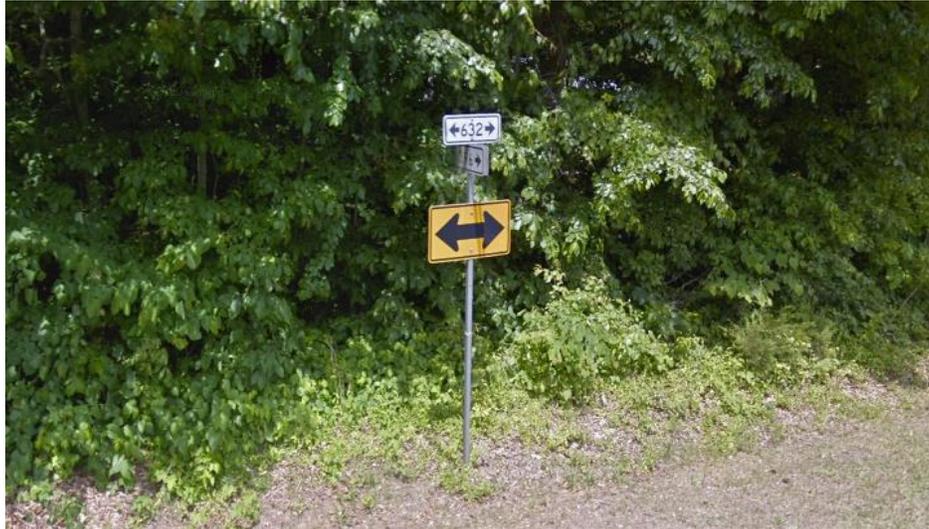
Figure 24. Example of a Two-Way Large Direction Arrow Sign (Source: Google Streetview)

This may be especially beneficial at T-intersections where angle crashes have been observed, such as Route 632/Hidden Rock Lane (Route 665).

The study team recommends that two-way large direction arrow signs (W1-7) be installed along the corridor at T-intersections for approaches entering Route 632. **Figure 24** displays an example of installed transverse rumble strips. W1-7 signs are present at some T-intersections along the corridor at present. The W1-7 sign can increase driver awareness and caution of cross-traffic for vehicles approaching Route 632.

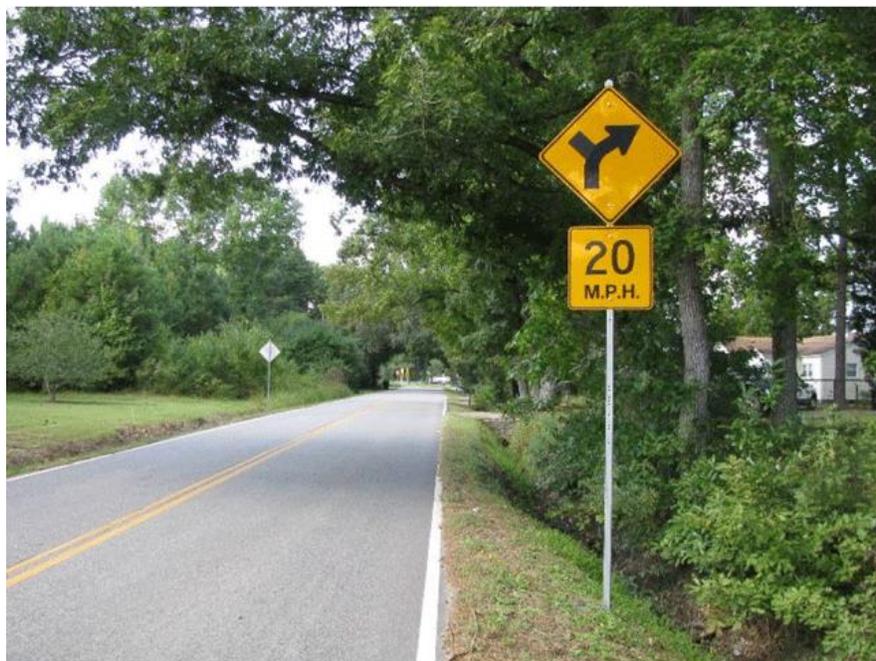
Figure 25. Example of a W1-10 Sign (Source: FHWA)

The study team recommends that horizontal alignment intersection warning signs (W1-10) be installed on approach to Route 632/637 (Hawk Town Road). Sight distance challenges are currently introduced by the horizontal curve in the roadway geometry. Installing a W1-10 sign can alert drivers of the upcoming intersection and possible turning vehicles up ahead (many rear end crashes happen at the eastbound approach). **Figure 25** displays an example of a W1-10 sign.
